PRELIMINARY ASSESSMENT

Maryland Air National Guard Base Martin State Airport Baltimore, Maryland

INSTALLATION RESTORATION PROGRAM PRELIMINARY ASSESSMENT

JULY 1988

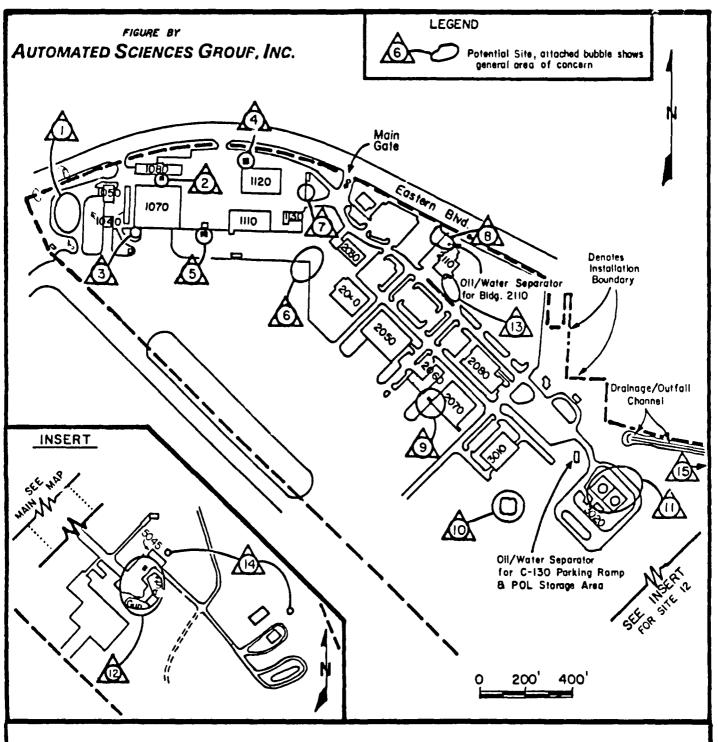
Figure 6. Locations of Potential Sites at Maryland Air National Guard Base , Martin State Airport.

- o Site No. 1 Old Underground POL Storage Area
- o Site No. 2 Leaking Underground Storage Tank (Bldg 1080)
- o Site No. 3 Hazardous Waste Collection Area (Bldg 1060)
- o Site No. 4 Leaking Underground Storage Tank (Bldg 1100)
- o Site No. 5 Leaking Underground Storage Tank (Bldg 1120)
- o Site No. 6 Old Aircraft Wash Rack (Bldg 2040)
- o Site No. 7 Removed Underground MOGAS Storage Tank (Bldg 1140)
- o Site No. 8 Motor Vehicle Wash Area (Bldg 2110)
- o Site No. 9 New Fire Training Area (Bldg 2070)
- o Site No. 10 Old Fire Training Area (Bldg 3010)
- o Site No. 11 Aboveground POL Storage Area
- o Site No. 12 Gun Butts
- o Site No. 13 Vehicle Maintenance (Bldg 2110)
- o Site No. 14 Non-Potable Wells
- o Site No. 15 National Pollutant Discharge Elimination System (NPDES) Areas

Initial investigative stages of the IRP Site Investigation are recommended for Sites 1-12 which have been identified as potential hazardous waste and/or spill sites. At sites 13-15, no evidence of contaminating events as a result of ANG activities was found. Therefore, these sites do not warrant any further IRP action.
